European Aggregates Industry

Health & Safety Good Practice Case Studies

Equipment case studies

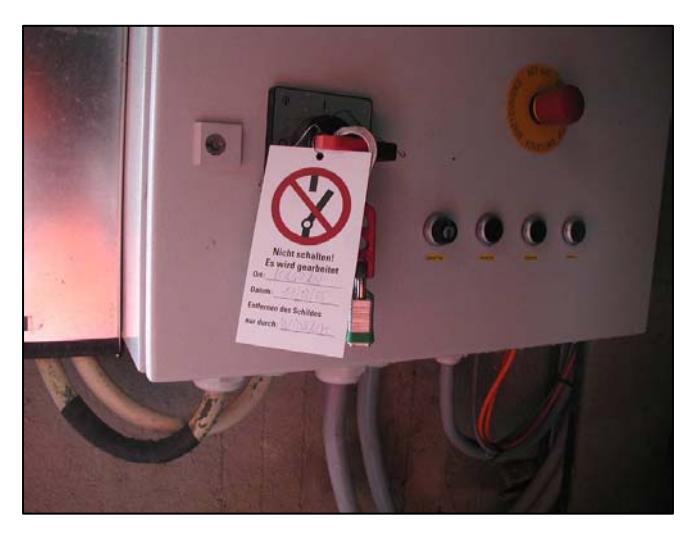
Working on dangerous machines

A Manual is used securing the maintenance while working on dangerous machines like crushers and conveyor belts. Double locking of the AC-energy switch is provided with lockers and name sheets, which can only be removed by a single person.

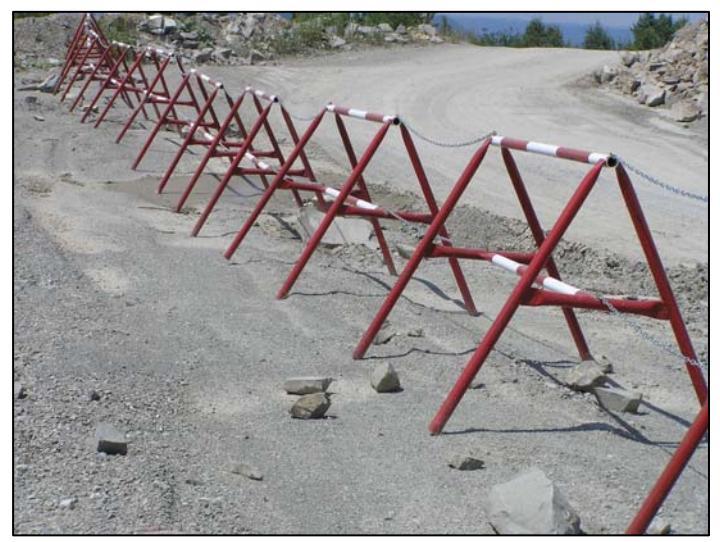
Steel barriers

Robust manufacturing of the steel structure is strong enough to provide support against a potential fall, but individual segments enable easy manipulation even by one worker.

Robust barriers from steel structures, highlighted by color, are placed at the edges of the quarry face. These eliminate the danger of falling people in these workplaces – mainly during drilling and blasting operations. These barriers, which prevent the danger of falling, are installed at all sites of Tarmac in the Czech Republic, where it is necessary.

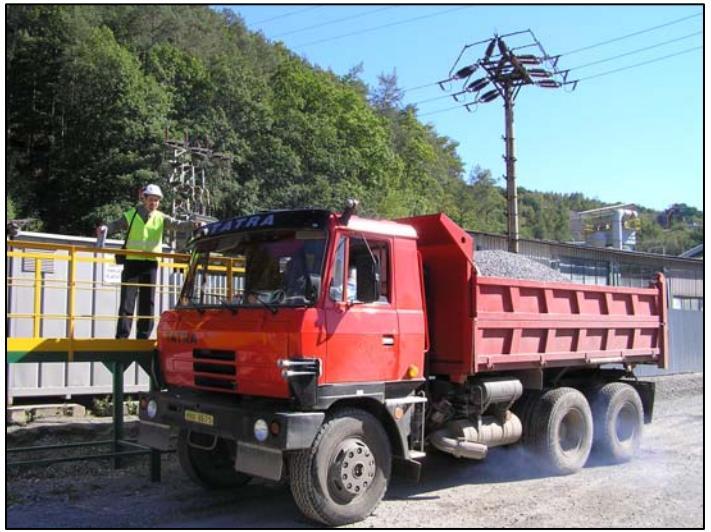
the sheeting of loads, so that there is no dust.

Operation ramps

For increasing of safety of truck drivers, we have installed at Tarmac CZ, at all sites, manipulation ramps used for safety checks of loads, taking of aggregates samples from a loading space, operating

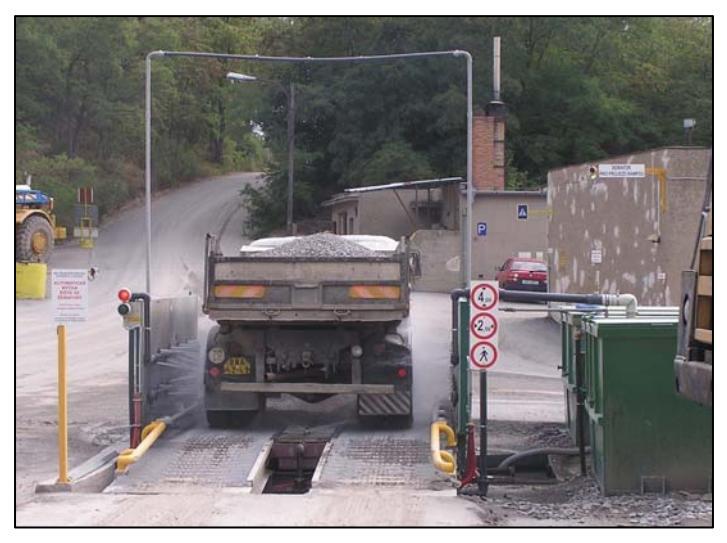
Automatic washing device

For increasing the cleanness of vehicles and for better communication at the site departure point, a new automatic washing device has been installed, which washes the chassis of vehicles by using pressurized

water. Water circulates through a bunker in a closed circle and so its consumption is not very high. Consolidated road links the washing device, so vehicles are at least as clean as they were on their arrival.

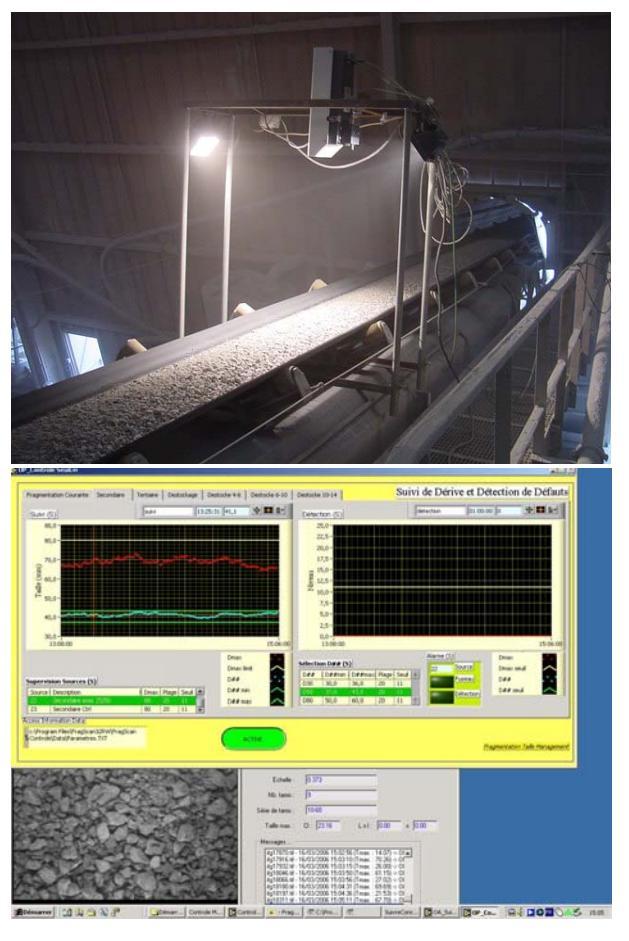
Automation of the adjustment of crushers

In order to reduce the exposure of the operators to dust, we automated the adjustment of the crushers. The monitoring of the adjustment is carried out by analysis of images taken by a camera on the exit conveyor of the crusher.

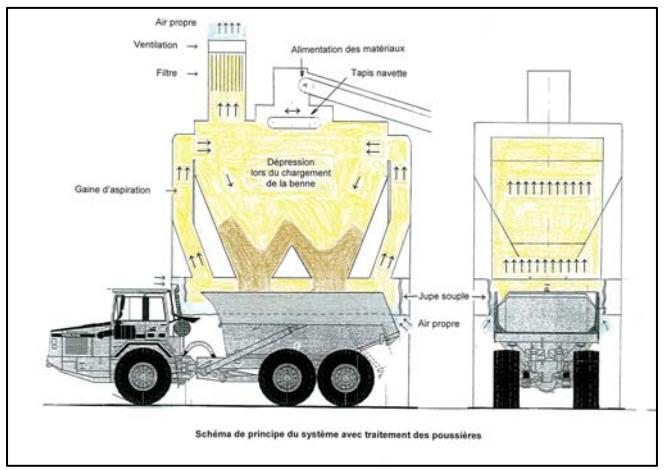
Loading systems for trucks in silos

The loading of the trucks under silos generates substantial dust. The quarry conceived and implemented an

innovating loading unit assuring a relative sealing around the lorry platform and using the depression due to both the unloading of the hopper and aspiration and filtration systems.

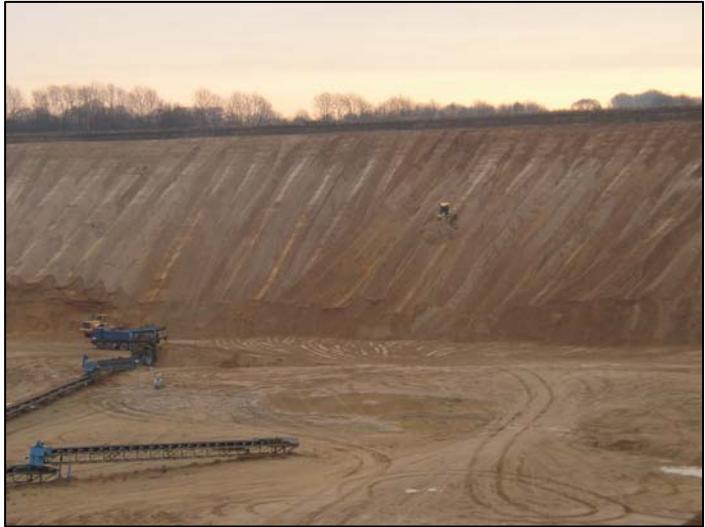
Reducing depth of extraction face

The official safety rules in Germany require that the upper level of the upper edge of the extraction embankment/face must not exceed the maximum

dredging height of the extraction equipment plus 1 m. The Rheinische Baustoffwerke GmbH ensures the fulfilling of this requirement in pits with extraction above groundwater level even in cases of face heights up to 40m by pushing down the material along the extraction embankment/face using chain dozers to an appropriate level.

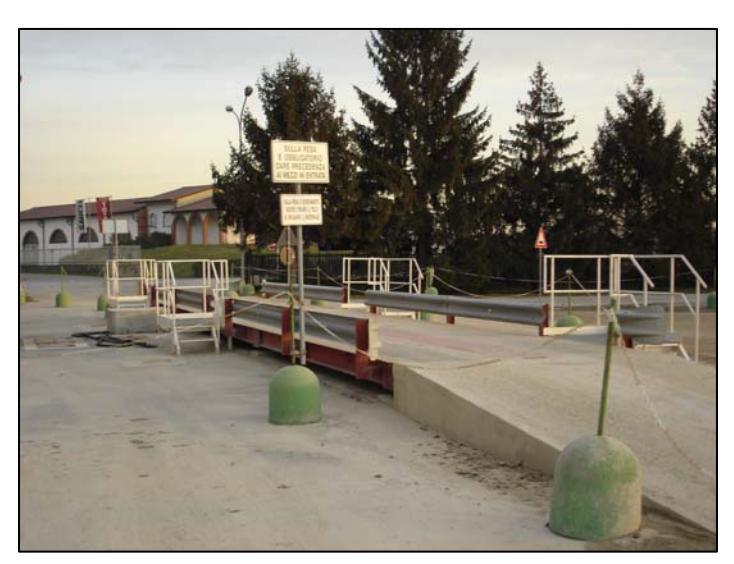
Hand railed weighing platform

The weighing platform has been equipped with handrailed walkways to facilitate the entrance and the getting out from the lorry's cab. The platform is also protected by guard rails to permit safe weighing

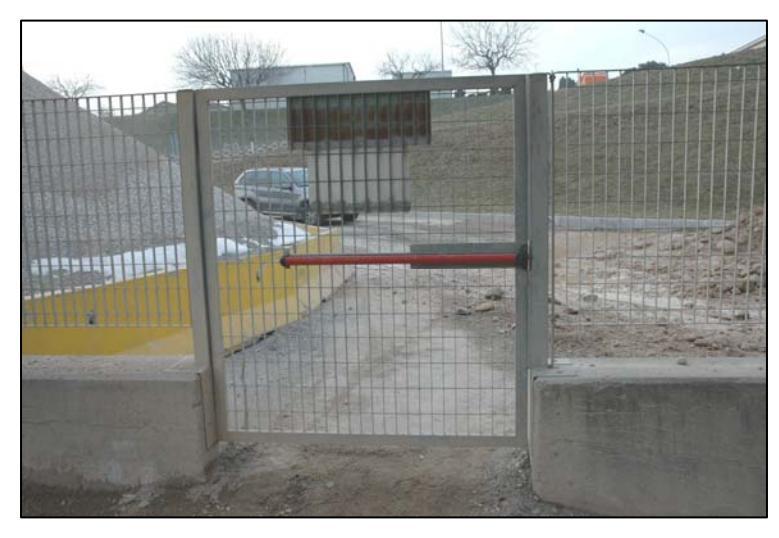
Secured quarry area

The plant area is completely cut off from the loading and circulation area by secure fencing (from 2 up to 3.5 meters). Only authorised people

may have access to the plant area for maintenance duties. The access is only possible via gates, guarded by a television camera, and opened only to authorised people.

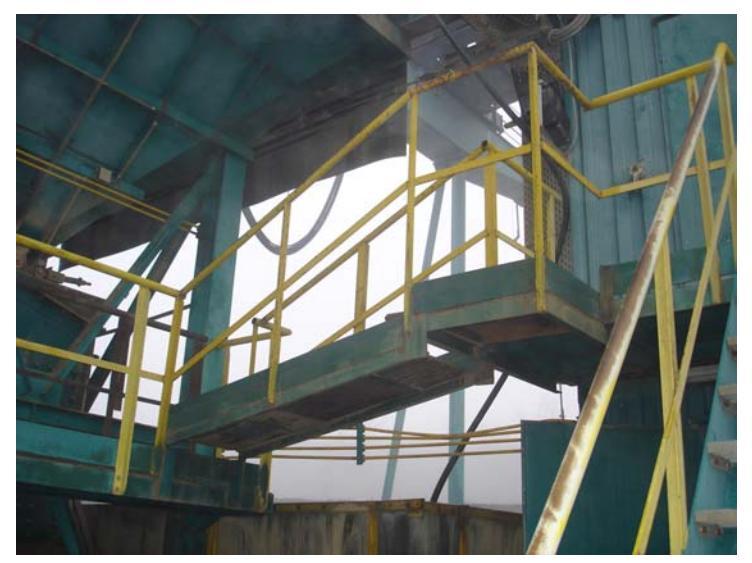
Safe Walkway

A new walkway, equipped with a handrail, has been added to connect directly the dredging operations control cabin and the tread way in front of the vibrating screen.

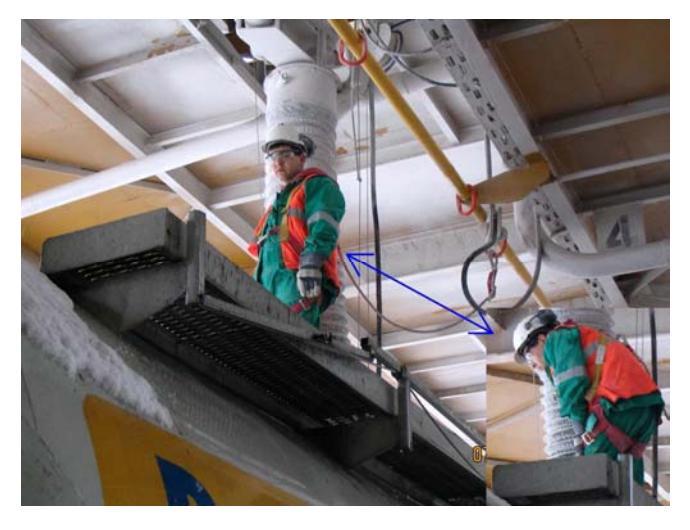
Filler loading station

The steel pipe (yellow on the picture) with moving rings (red on the picture) is mounted on the existing construction of the cement truck loading station. Operator equipped with the safety harness snaps the end of the life

line by the shackle (catch) to the moving ring. Then the operator is able to walk on a truck catwalk and to load safely the truck using a slope chute.

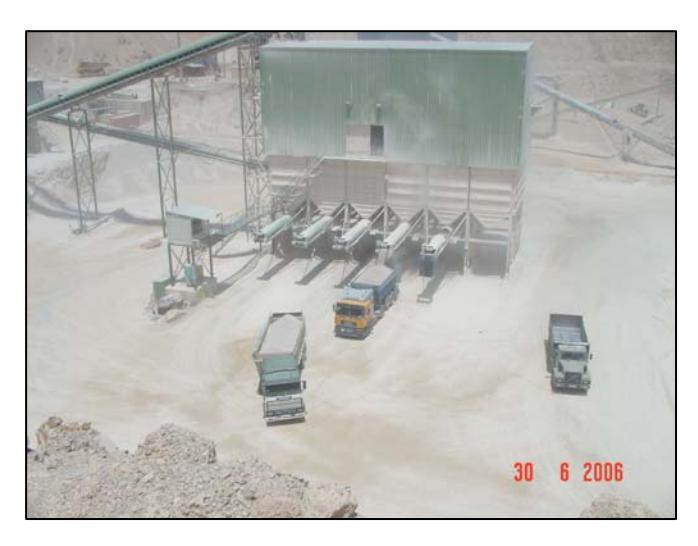
Control room for loading trucks

The control room with a central command has been established for loading trucks for dispatch and to put in

different storage places according the different limestone aggregates particle size. The implementation of this practice improved productivity because one can load simultaneously six trucks with different aggregates.

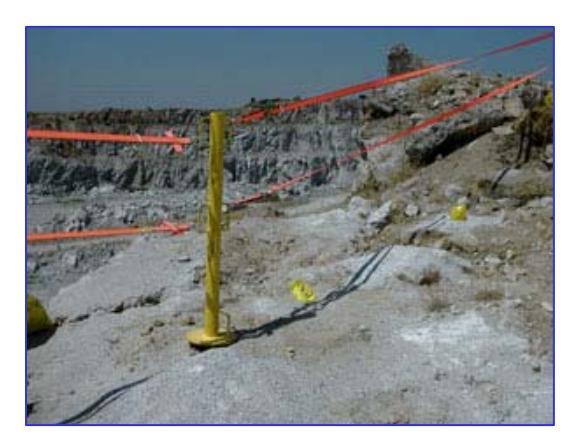
Anti-fall protection at the face

The company has introduced a protection system to avoid falls from various levels at the face during bore drilling and the loading

of explosives. Use of this system, designed in the United Kingdom, is mandatory in all the company quarries. This is a mobile system comprising two posts inserted into the ground at a safe distance from the face and to which the lifelines are secured which the employees wear on their anti-fall belts. This protection is installed before the work begins on drilling the bores, and is withdrawn before blasting.

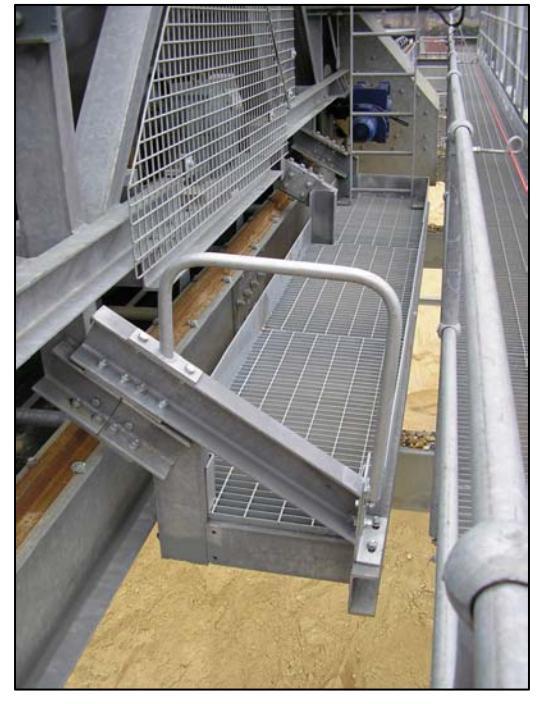
Travelling platform

During a ship to shore conveyor reconstruction at this wharf, staff identified issues governing the lack of access to both the conveyor rollers and the motor for the Gravity Take-up Unit (GTU), which resulted in difficulties carrying out standard maintenance. Lafarge, in conjunction with its conveyor construction company, decided to lower the GTU to floor level for ease of maintenance, and to construct a travelling platform at the top of the conveyor structure so that all the conveyor rollers could be accessed for cleaning and maintenance.

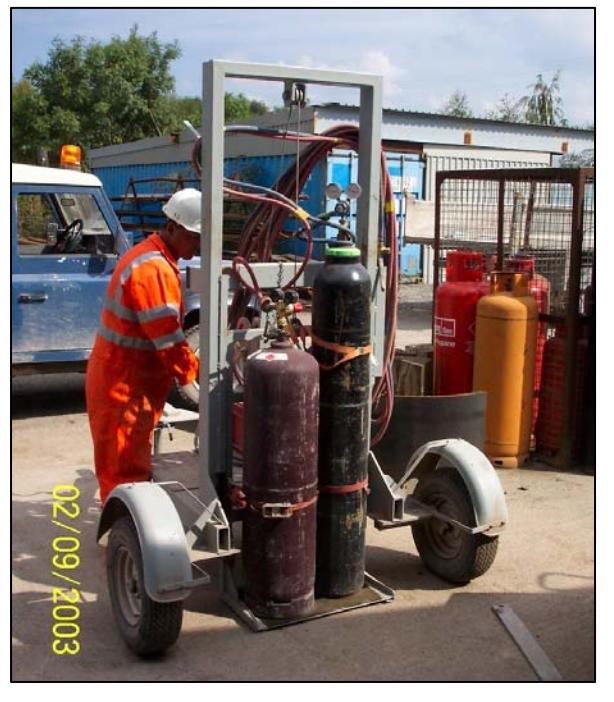
Transporter for for heavy gas bottles

The fitting department at Chipping Sodbury Quarry has designed and fabricated a transporter that makes handling heavy gas bottles a far safer process. A trailer with a winch at the rear lifts the bottles from ground level on a base plate that can be fixed in position. The design incorporates a holster to prevent the gas nozzles being damaged during transit, a bracket to store a fire extinguisher and protruding brackets to keep the hoses neatly stored.

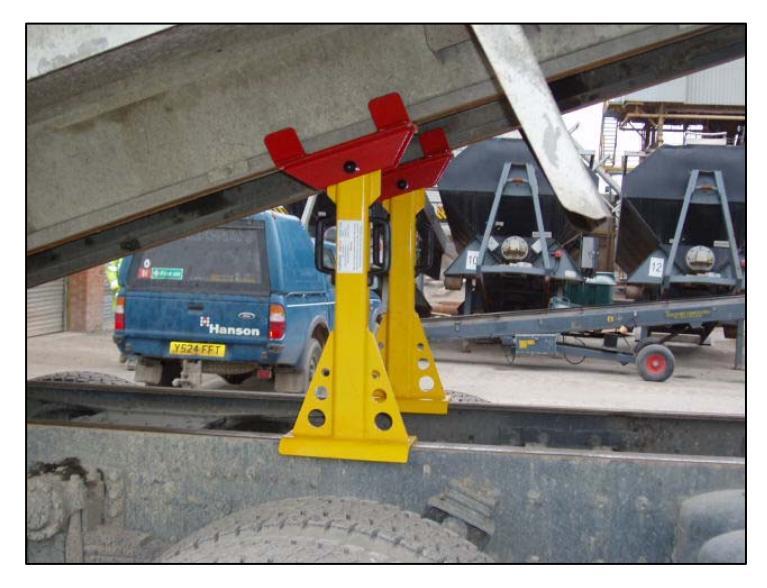
Body props in case of hydraulic failure

Hanson Aggregates identified a trend in the company's South East region of tipper vehicle drivers inspecting or maintaining their trucks with the

body raised, but without employing sufficient safeguards against a hydraulic failure. This was discussed at the area safety representatives' meeting and a suggestion was put forward to provide purpose-built body props at all sites. The props are lightweight and easy to handle to both encourage their use and allow them to be placed in position without undue effort. They are also universal and will fit all body types. Prior to their issue, the driver is talked through the safe working practice and issued with a set of instructions. Now all quarries and asphalt plants in the region have two body props, held in the weighbridge, for use by delivery drivers as and when required.

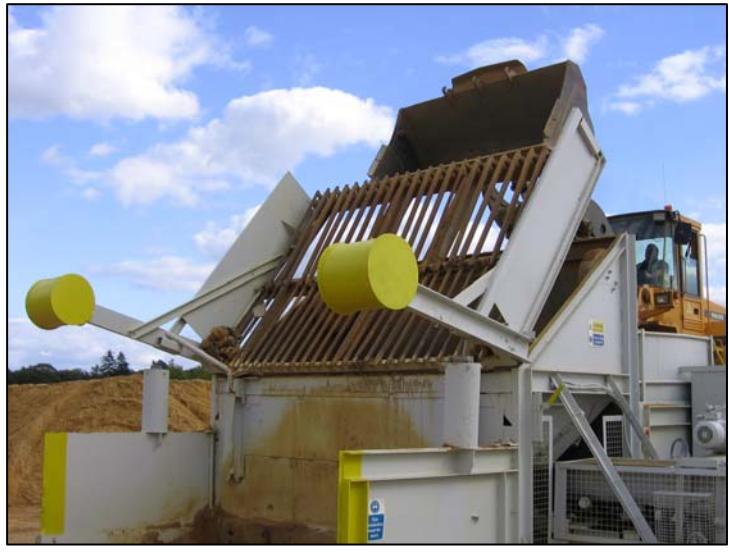
Self-cleaning hopper grid

Following a risk assessment of gaining access to the hopper grid to remove clay and deleterious material, a self-cleaning hopper grid has been designed and

manufactured by the workforce, which avoids manual handling and can be adaptable to any type of hopper. The loading shovel approaches the hopper and puts the bucket blade under the lifting bar. The operator then flicks the bar with the bucket blade causing the grid to pass the point of balance, which causes the finger bars to move forwards, removing clay and deleterious material before the spring mounted stops cause the grid to return to its seating.
